Natterer's Maternity Roost at Peckforton Castle, Stonehouse Lane, Peckforton

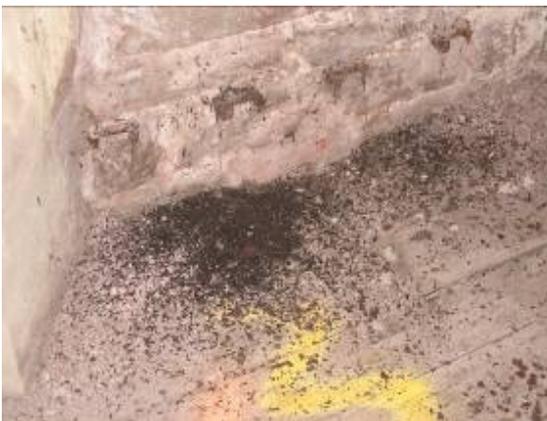
Large accumulation of droppings below cavity

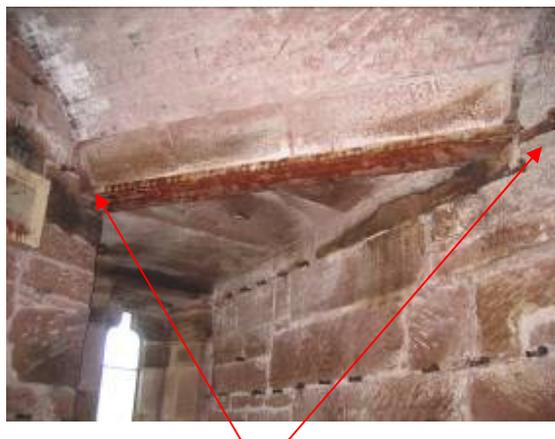
Two of three roost entrances in wall cavities

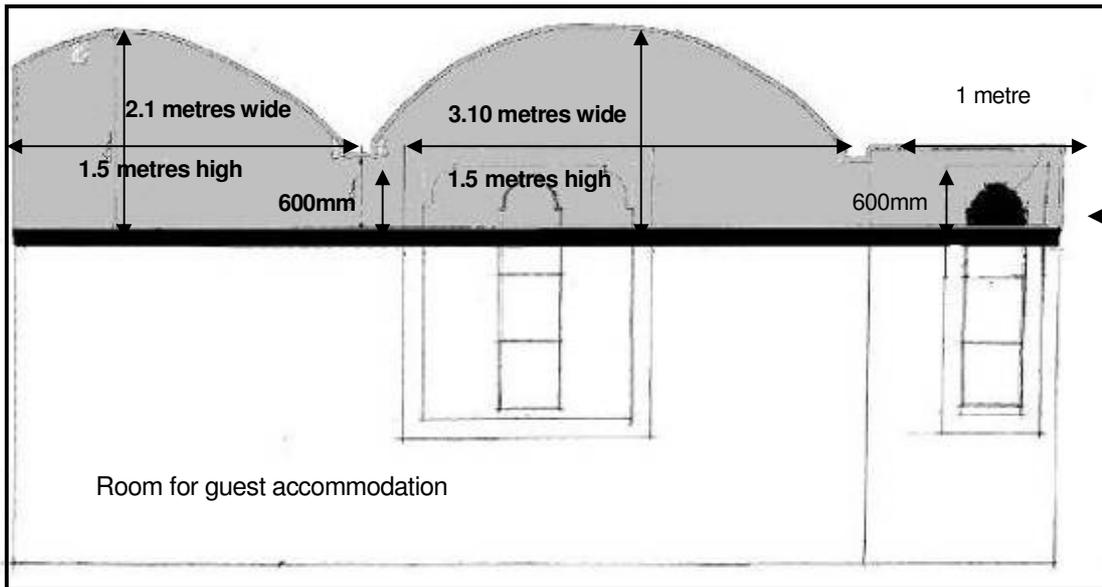
Modified window exit to dimensions of 300mm high x 400mm wide

Subsequently in early 2013 a ceiling was constructed, which retained the existing roosts (See Figure 1) and most notably the two barrel arches within which the bats were using for pre-emergence flight were also retained. The window at which bats exited/entered was modified to a reduced size (300mm high x 400mm wide) and was designed at a downwards angle to facilitate a natural downward exit to nearby woodland and an upwards angle to allow a natural flight line into the created void above the room. (See Figure 2)

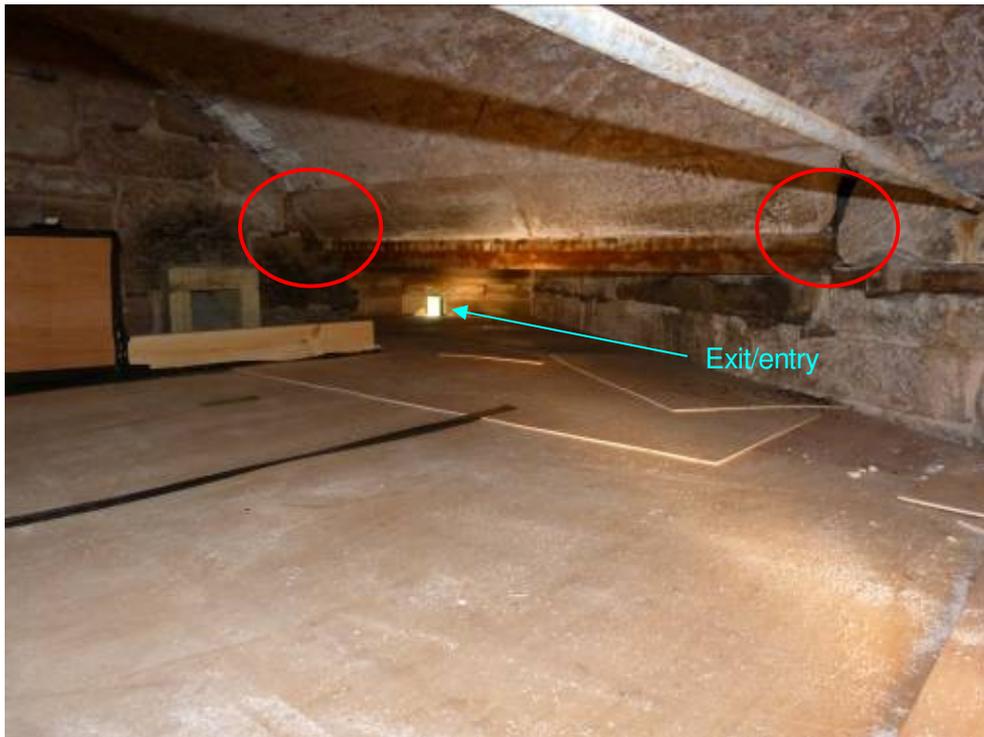
Figure1:

Roost void with two of three roosting cavities

Within the void a temperature data logger and a CCTV camera has been installed to monitor the roost; the latter has proved to be very useful; over three manual monitoring visits during June – August 2013 the following results were recorded, although the many many hours of footage has not yet been fully assessed. A hatch has also been installed to allow the periodical removal of droppings.

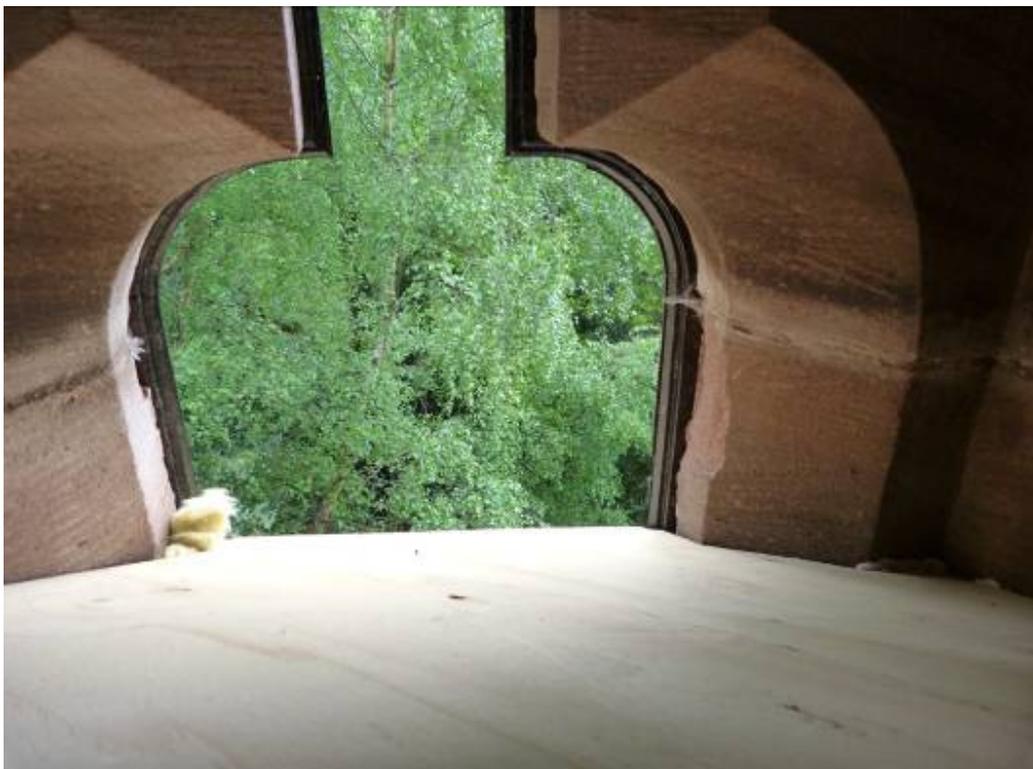
Figure 2:

Modified window to provide natural flight lines in and out
